A Report on the Excavation and Analysis
of the Gold Rush-Era Ship *Rome*
San Francisco, California

William Self Associates
Orinda, California

March 1996

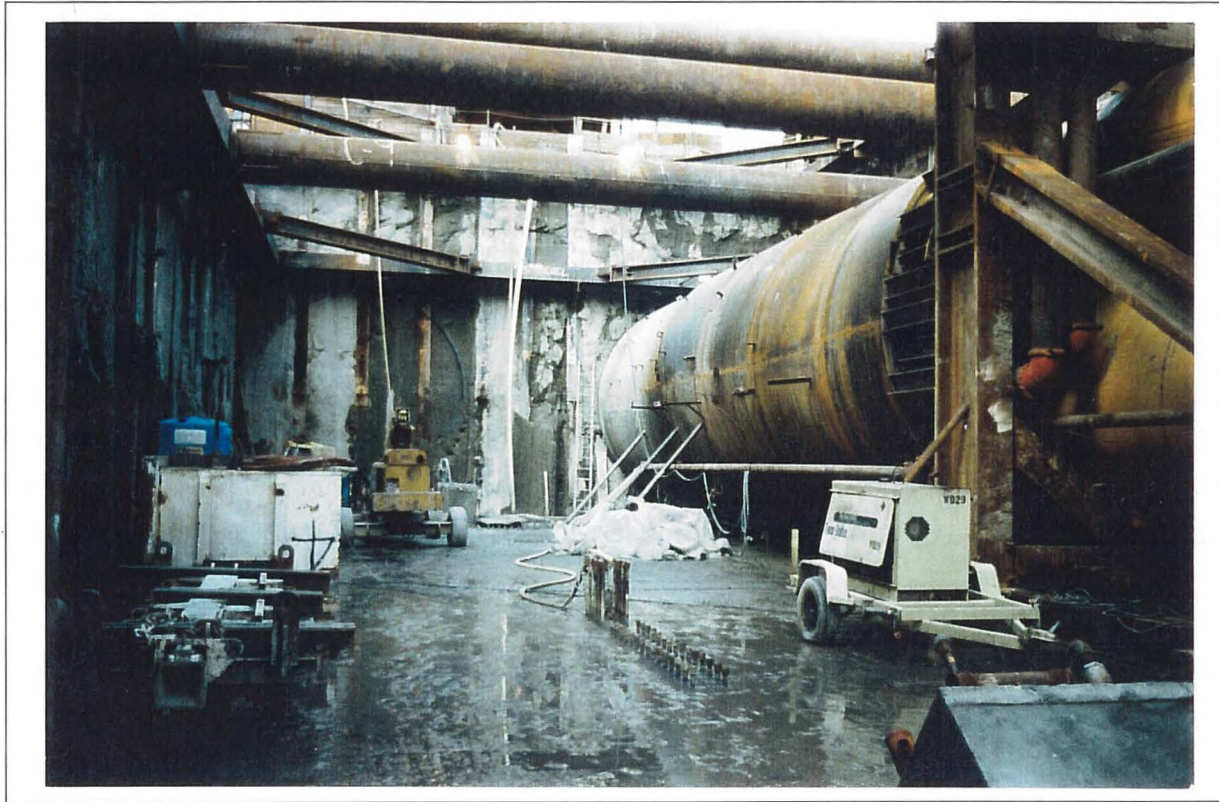
Photo 1 Bulkhead - View to the west from invert (Equipment airlock to right)

corner of Justin Herman Plaza to Mission Street, Area 2 from Mission Street to Howard Street, and Area 3 from Howard Street to grade at Folsom Street (refer to Figure 1). Construction of the SPTC walls began in the northern portion of Area 1. To build the walls, 36 inch-wide flange steel soldier piles were driven into bearing strata, below the bottom of planned excavation, on 12.5 ft centers. Soil was removed from the "slot" between each pile with a "clam shell" excavator to a depth of approximately 60 ft. Intermediate soldier piles were then installed in each slot, between the initial soldier piles. Concrete was pumped into the slots between the soldier piles to form the SPTC wall. The northern end of the cut-and-cover excavation was defined by a bulkhead constructed in similar fashion that crossed the width of the excavation, perpendicular to the two parallel side walls (MMTP AMDRP 1992, sec. 3.1)(Figure 2; Photo 1).

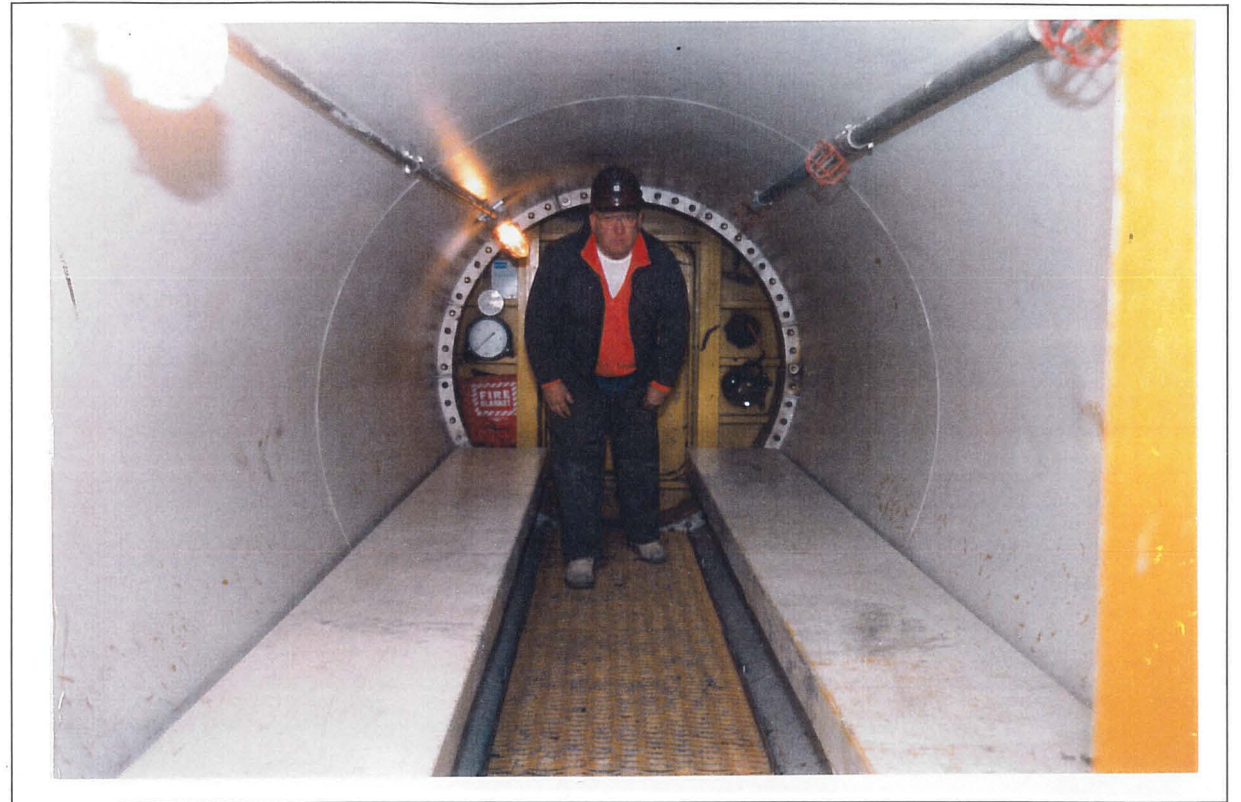
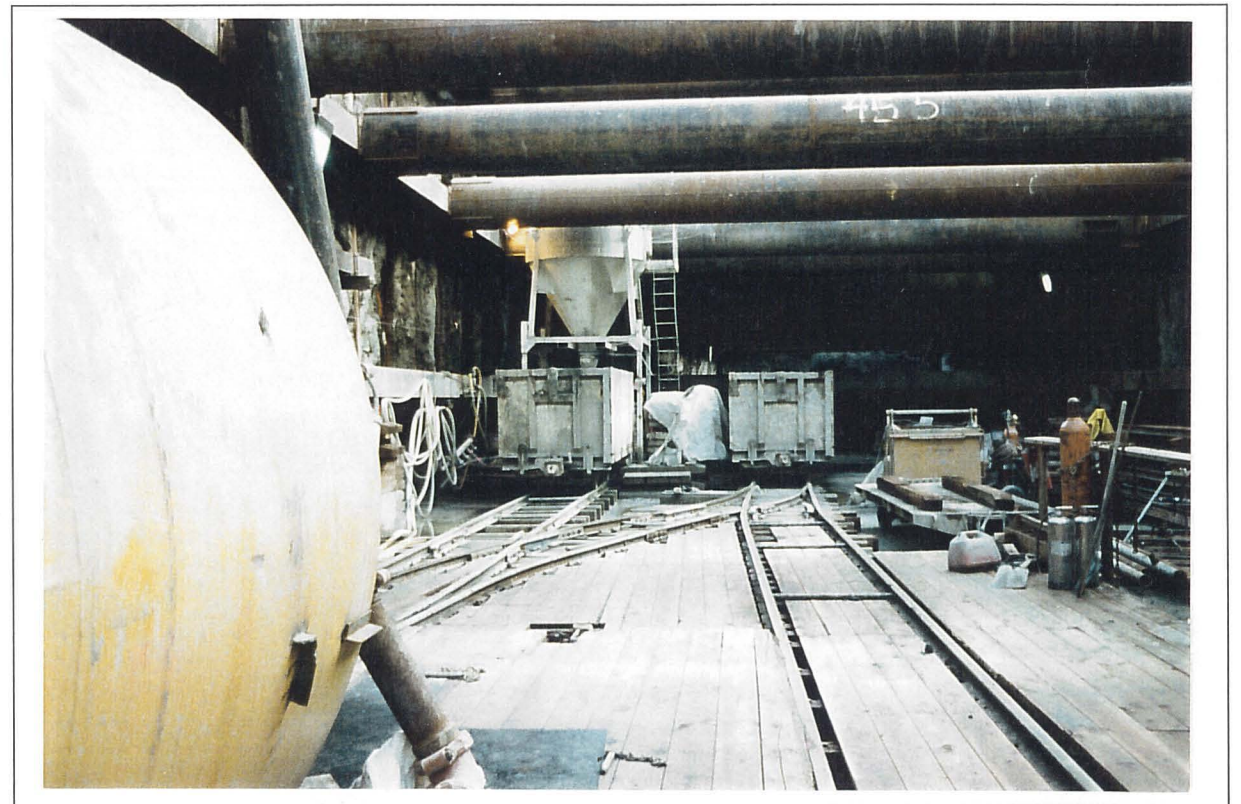
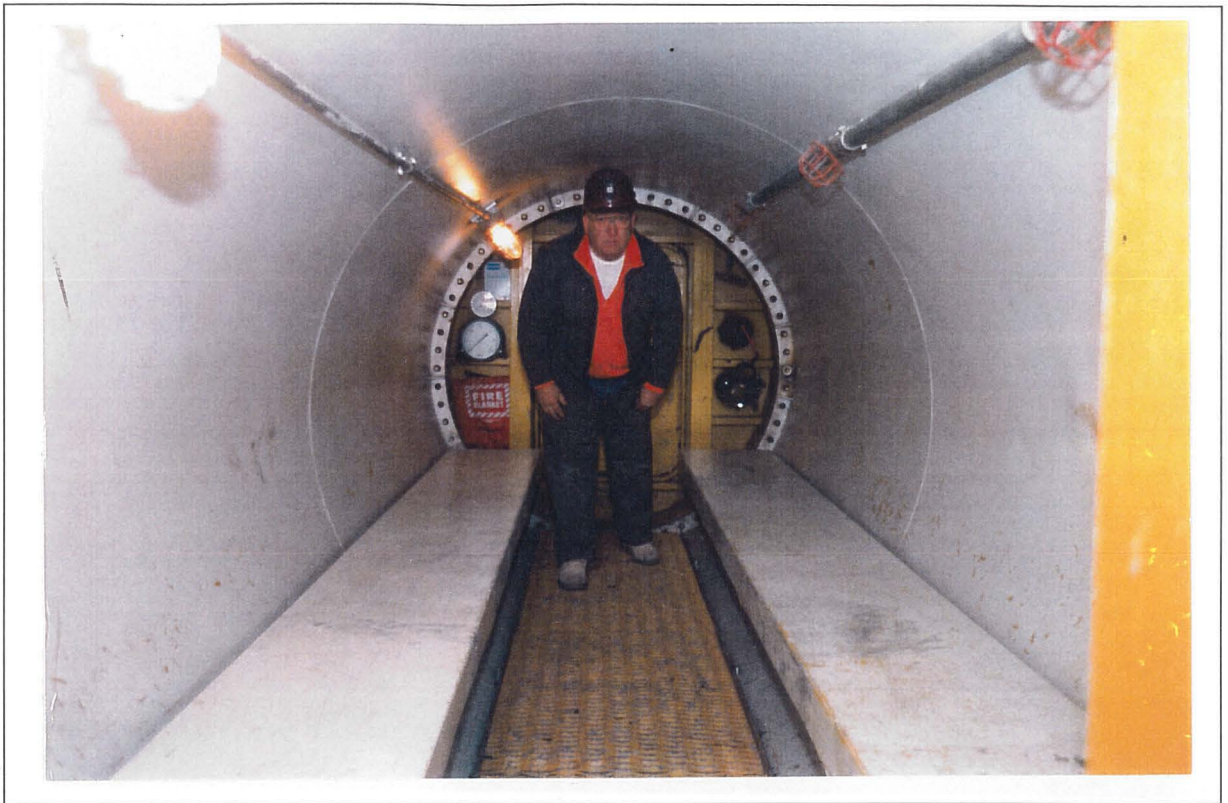
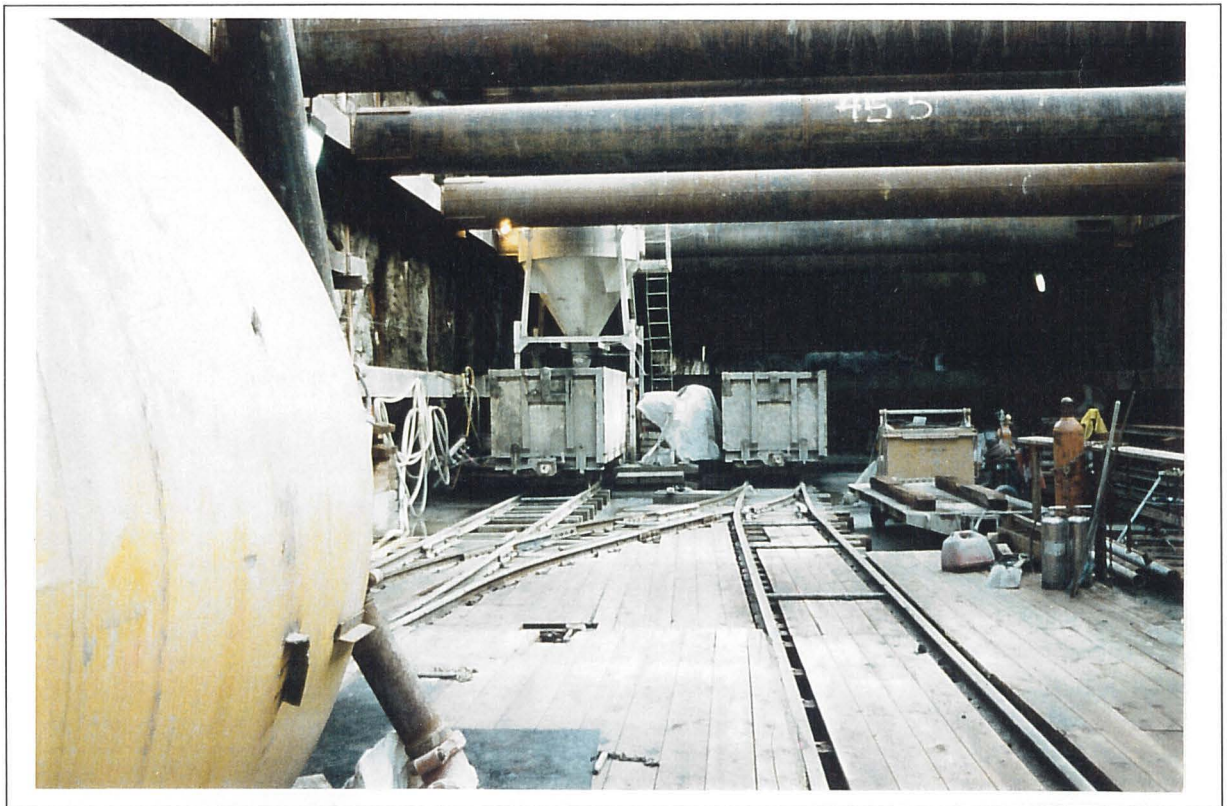
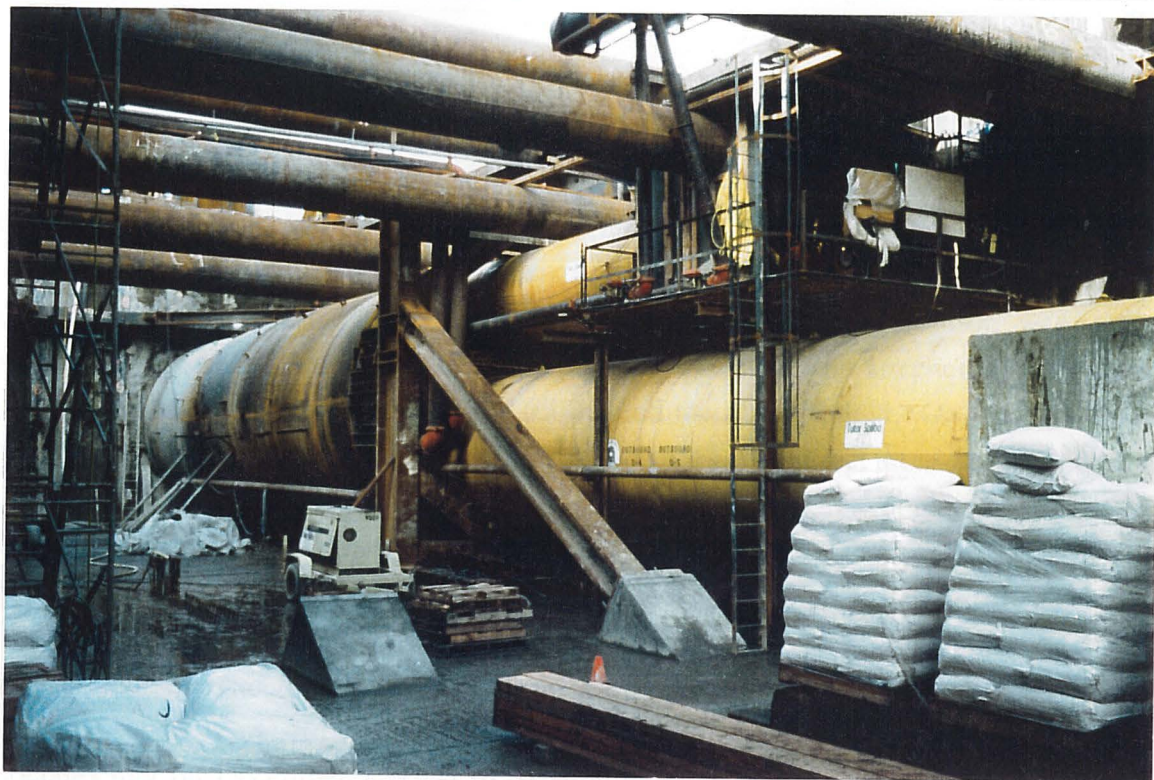
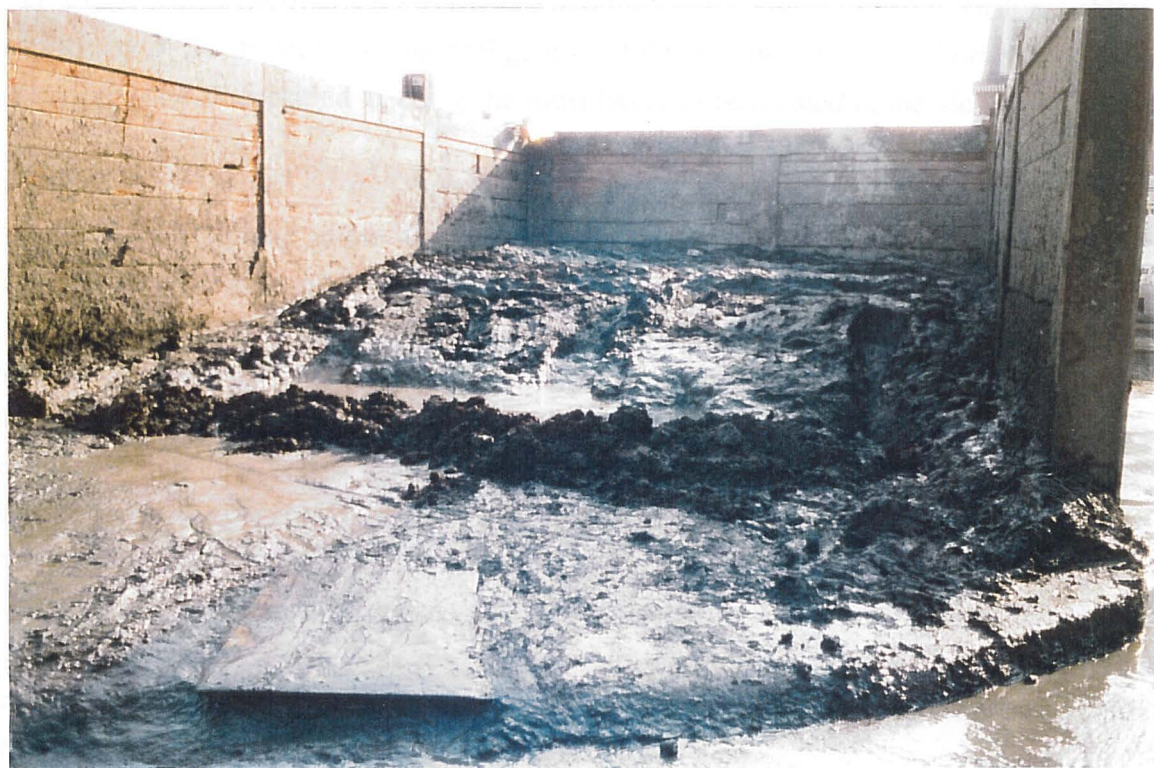
Photo 2 Air lock

Photo 3 Mining cars - view to east from invert

Photo 4 Air locks - view to northwest from invert

Photo 5 Muck bin

Spoils from the tunnel excavation were loaded by conveyor belt into small mining cars that were transported to an equipment air lock at the tunnel entrance. Through the air lock, the mining cars were removed from the pressurized tunnel environment, lifted by crane to the surface, and emptied into a "muck bin" prior to their removal from the site to a contract landfill site (Photos 2-5).

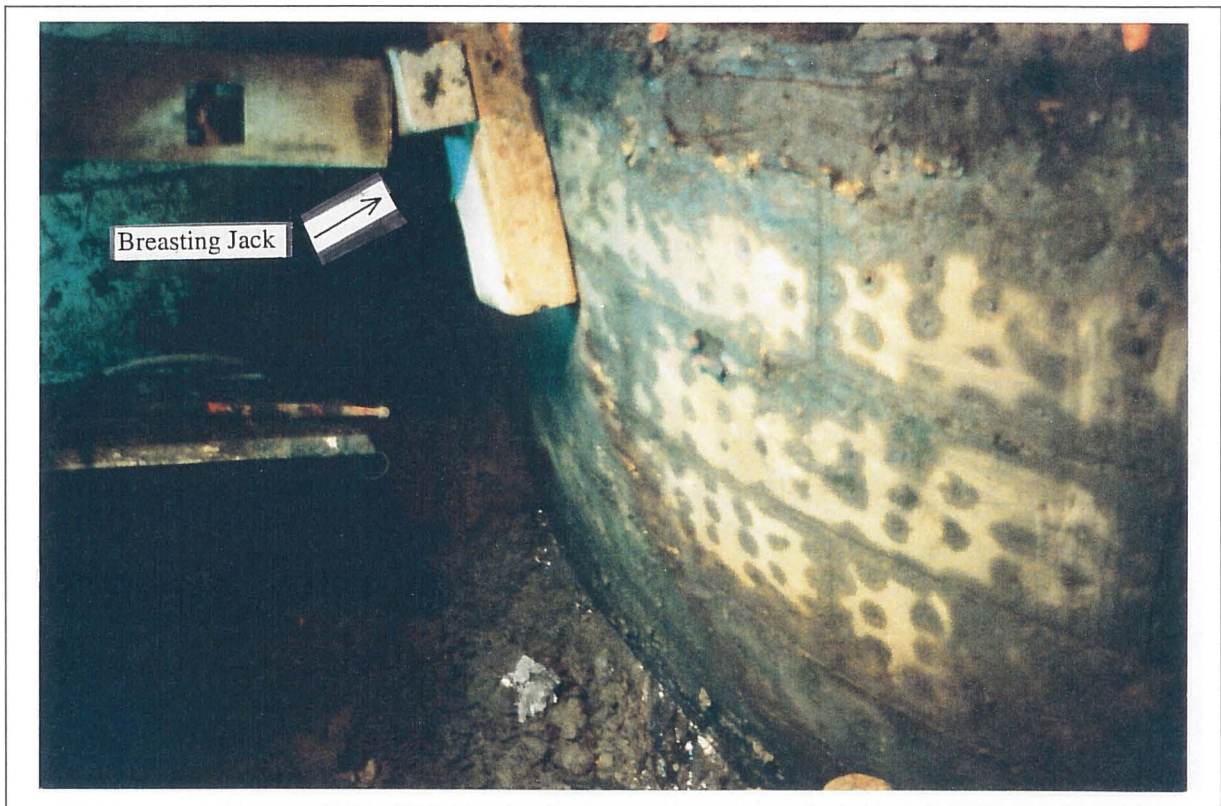
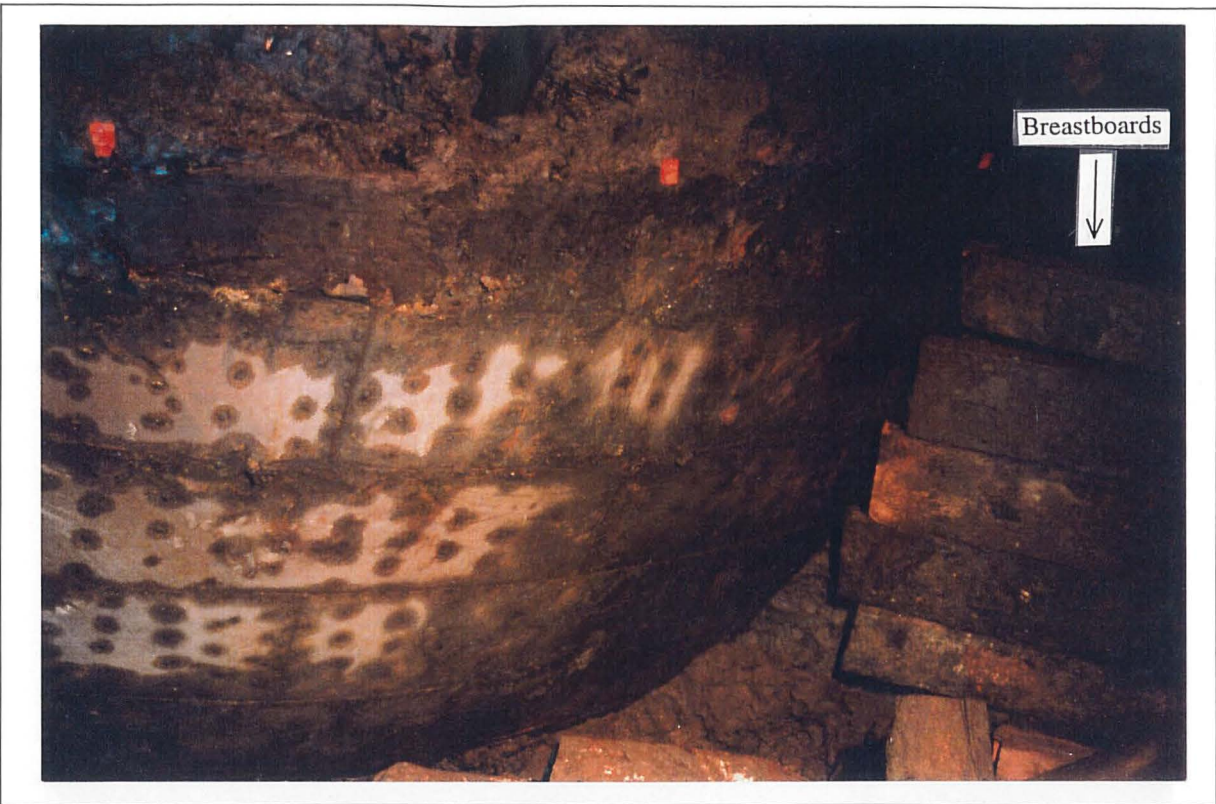
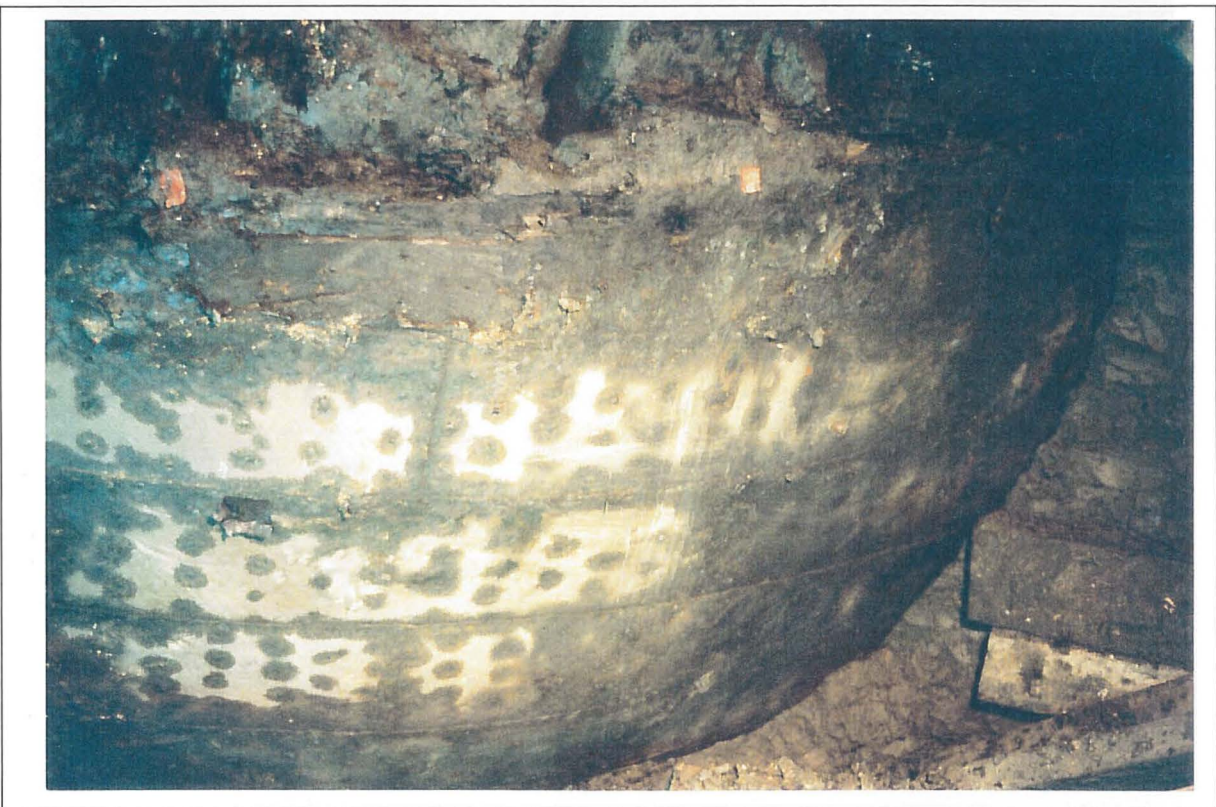
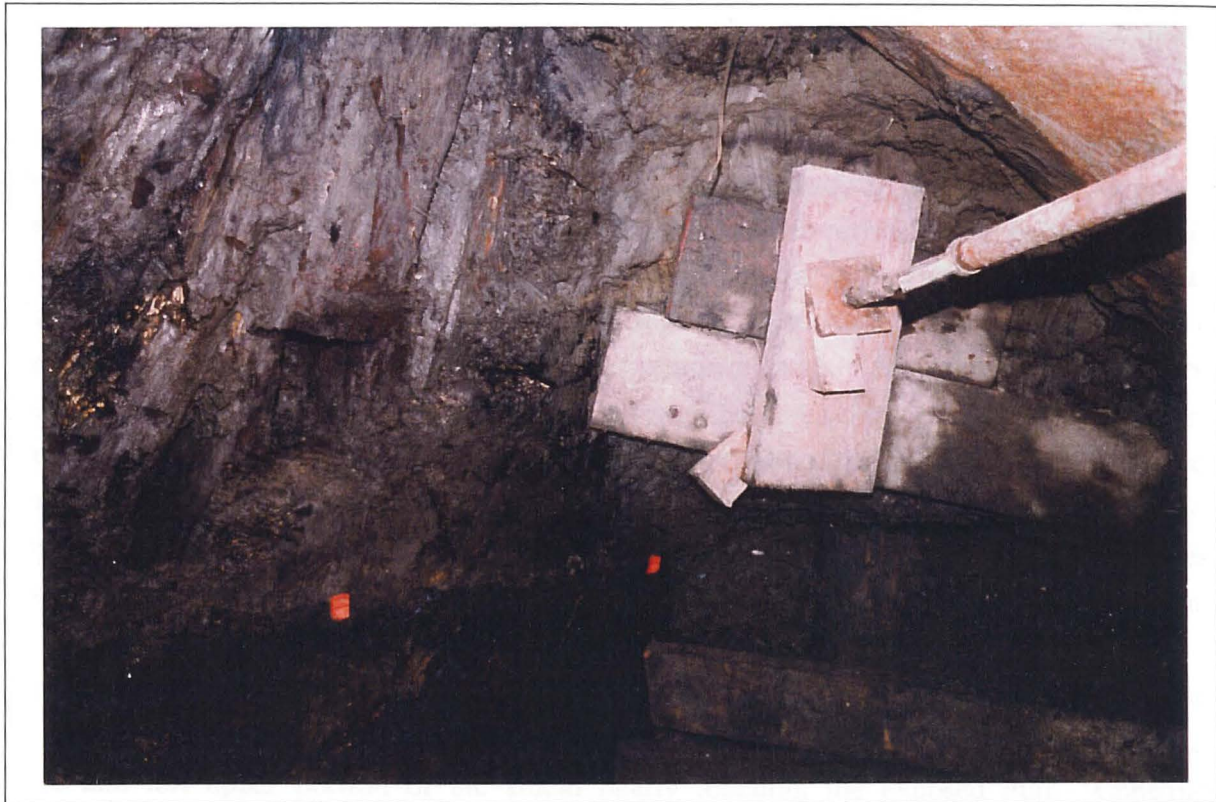
Photo 6 Lower hull - left side of tunnel face

Photo 7 Lower hull - view to the south

Photo 8 Lower hull - right side of tunnel

Photo 9 Lower hull - view to north

Photo 10 Detail of frames embedded in bay mud

The proximity of the ship to the historic location of the *Rome*, as discussed below, prompted a preliminary identification of the ship as being the *Rome*. Still photographs and videotape of the vessel were examined during the course of the meeting. These depicted the copper-sheathed lower portion of a ship's hull, visible from about the mid-line of the tunnel face to the bottom of the tunnel shield. The upper part of the tunnel face, above the line of sheathing, consisted of a heavy mud and clay matrix in which were embedded exposed wooden frame sets from the ship's interior. It appeared that the wooden hull planking that should have been attached to and covering these frames above the line of copper sheathing had been removed or had rotted away. On the right side of the tunnel face and adjacent to the hull was an intrusive vertical wood piling. Because the excavation had encountered the ship at the approximate waterline of the hull, virtually the entire tunnel face was filled by the hull, precluding the need for breast boards and enhancing the visibility of the hull (Photos 6-10).

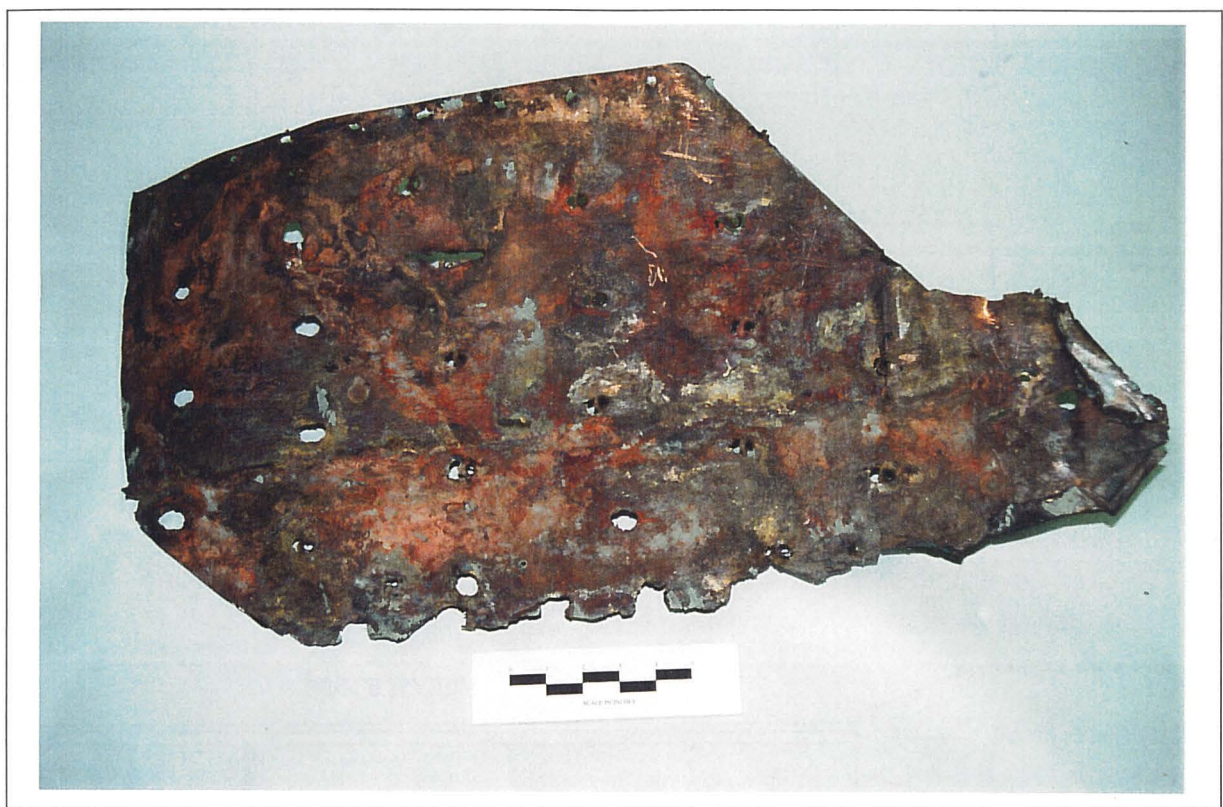
Photo 11 Copper sheathing

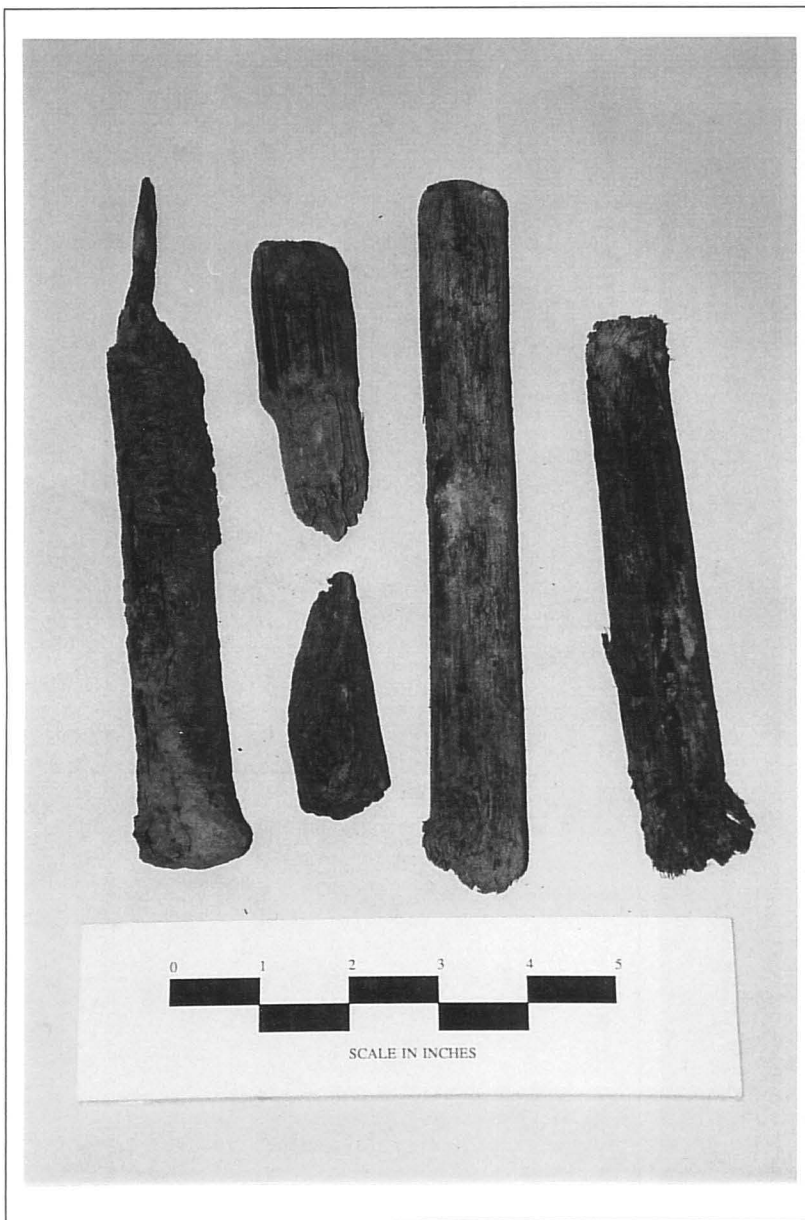
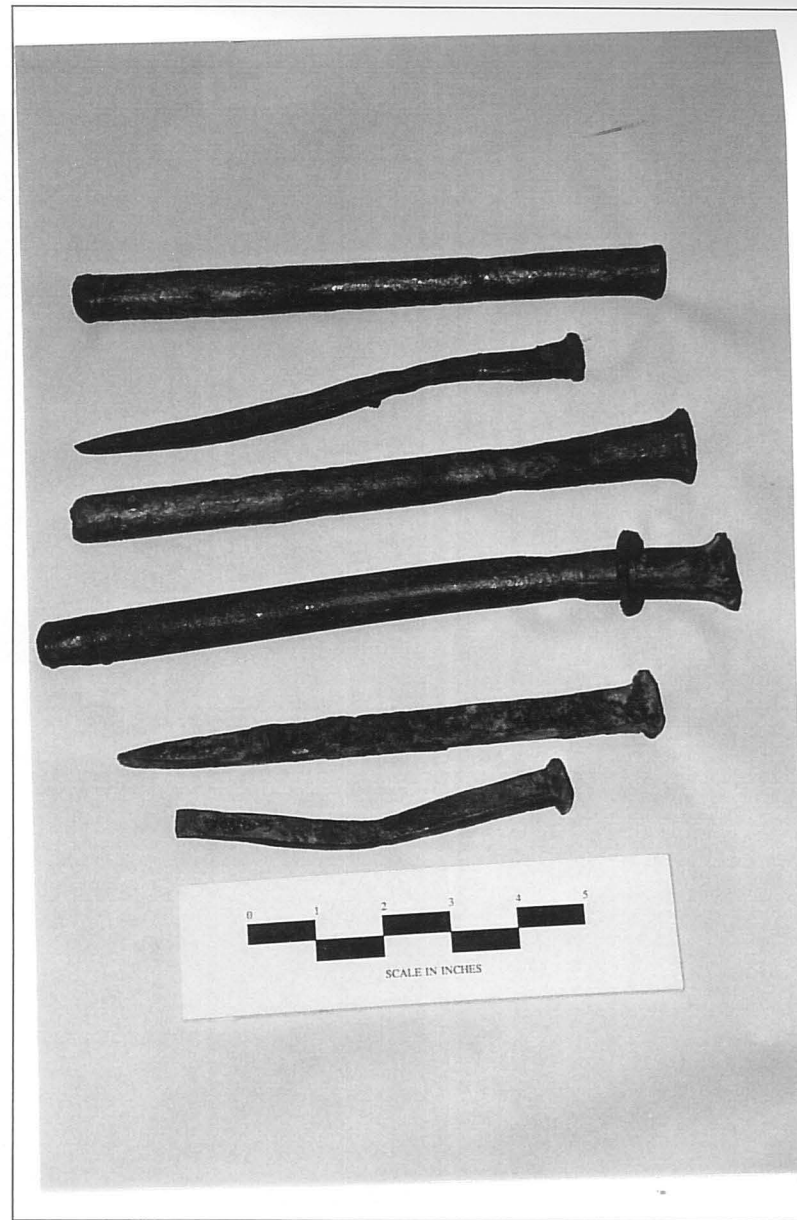
Photo 12 Treenails and degraded iron fastener

Photo 13 Bronze fasteners

Photo 14 Bronze drift bolt

As depicted in Figure 13, the tunnel bore, measuring 18.5 ft. in diameter, was driven at an angle across and through the forward portion of the ship. Excavation requirements and tunnelling safety considerations (which naturally precluded archeological preferences) limited all but the most cursory and visually restrictive observations of the ship's construction. From what little could be observed *in situ*, and from analysis of the structural fragments recovered on the surface, the centerline of the tunnel excavation appears to have encountered the hull approximately 16 ft. forward of the foremast at an angle of approximately 45 degrees. The exterior of the hull was copper sheathed, with each sheathing plate measuring approximately 1 ft. x 4 ft. (Photo 11). Each plate was overlapped with a seam of approximately 2 inches. Thin furring planks of juniper or cedar,³ .25 inch in thickness were attached to the hull planking, beneath the copper sheathing. A coating of pitch and felt had been applied to the exterior surface of the furring planks. The hull planking itself was fabricated from white oak and, although not measured *in-situ*, fragments recovered on the surface measured approximately 3 inches in thickness with widths of 12 to 14 inches (Figures 14-18). Planks were fastened to the underlying double framesets predominately with treenails (wooden dowels), although bronze spikes were used as well (Photos 12, 13, 14). The double frames were fabricated from white oak.

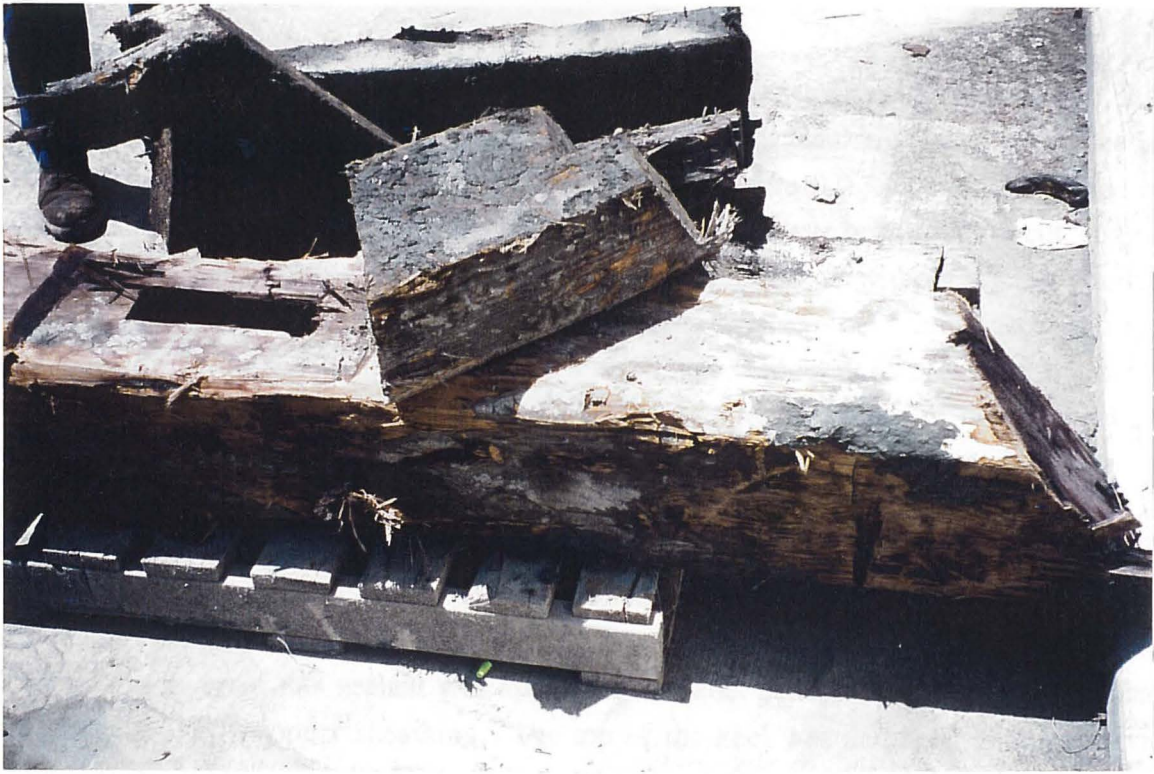
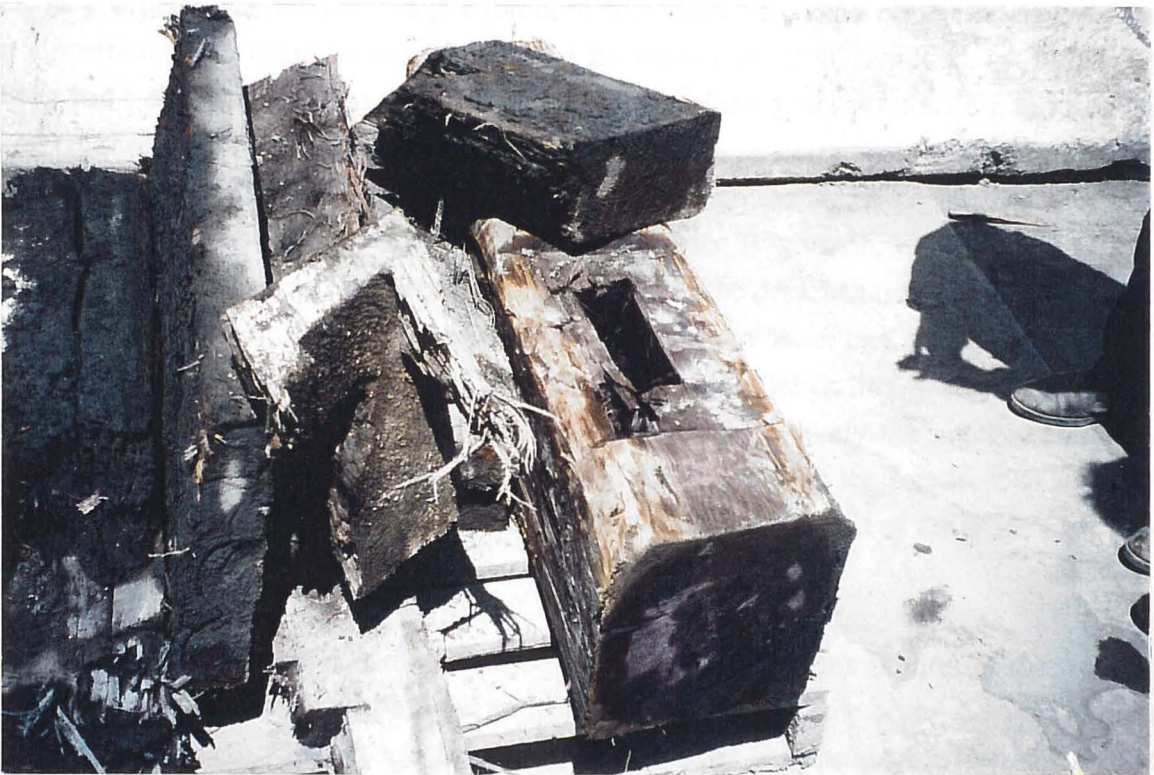
Photo 16 Maststep

Photo 17 Maststep

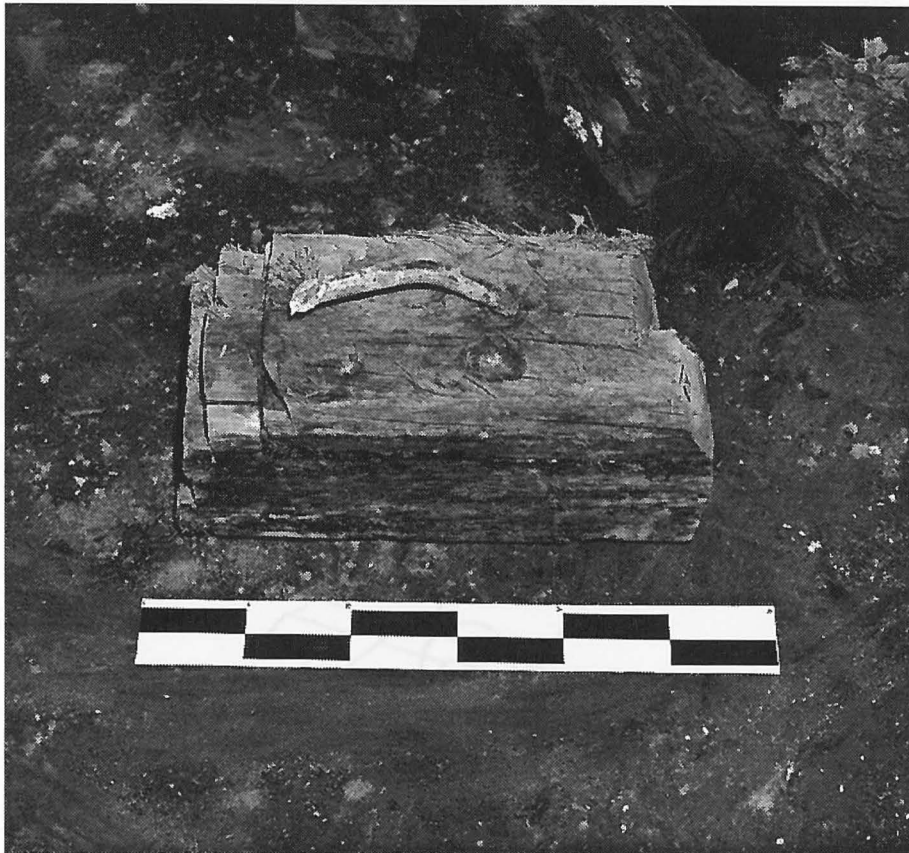
Figure 34
Rabbet and Garboard Strake

The ship's keel was fabricated from white oak and measured 13 in. x 17.5 in. Analysis of the keel fragments recovered on the surface indicate the keel had also been sheathed in copper. There was no evidence of a false keel. Residual tar and pitch on the moulded surfaces of the keel indicate a layer of this sealant was applied to the keel beneath the furring planks that lay underneath the keel's copper sheathing. The top of the keel was damaged during excavation, obliterating any evidence of the back rabbet. The remaining portion of the rabbet measured 3 to 3.5 in. (Figures 33, 34, Photo 18). The garboard strake was not recovered.
